AlliedWare Plus Software Maintenance Release Note

Software Version 5.4.2-3.16 for SwitchBlade x8112, SwitchBlade x908, x900, x600, and x610 Series Switches

This document lists the issues addressed and enhancements in AlliedWare Plus™ software maintenance version 5.4.2-3.16. This document applies to the following switches:

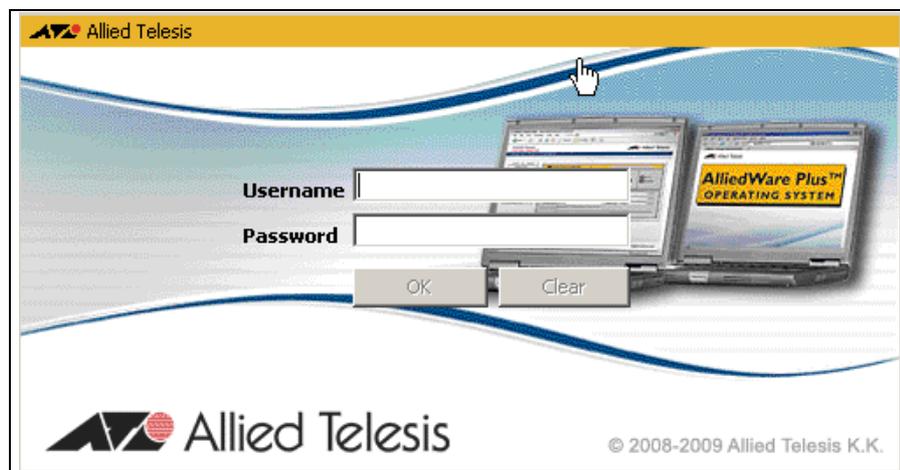
7. Log into the GUI.

Start a browser and enter the IP address you configured in Step 3 as the URL. You will be presented with a login screen after the GUI Java applet has started. Log in with the username and password that you defined in the earlier step, named **Create a user account**.

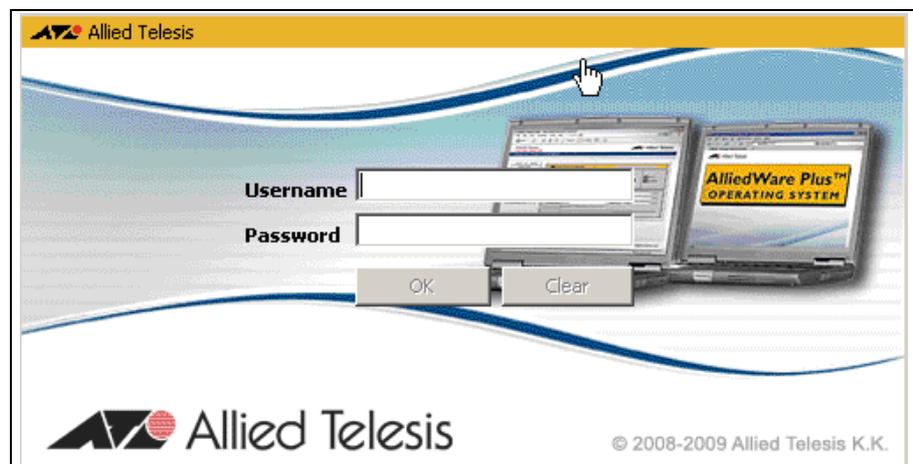
7. Log into the GUI.

Start a browser then enter the IP address you configured in Step 3 as the URL. You will then be presented with a login screen after the GUI Java applet has started. You can then Log in with the username and password that you defined previously in Step 6.

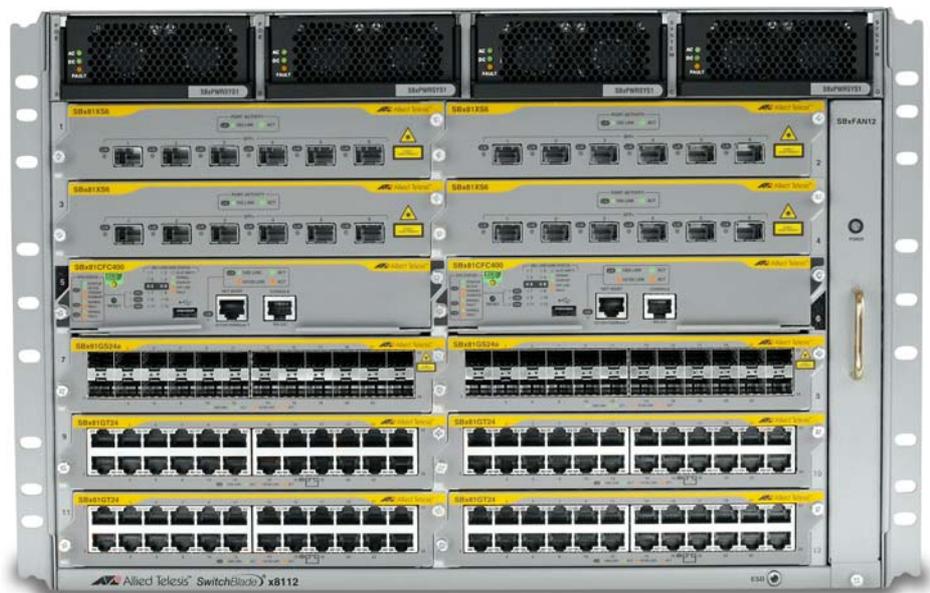
Figure 1: SBx8112 chassis with line and controller cards installed

The Allied Telesis SwitchBlade x8112 is a high performing scalable solution, providing an extensive range of connectivity options. Dual control cards are partnered with 10 line card slots. Gigabit and 10 Gigabit line card options ensure a system capable of meeting the requirements of today's networks, and the flexibility to expand when required.

SwitchBlade x8112 is a 7-rack-unit modular chassis comprising:

- Controller Fabric Card (CFC) slots x2
- Line card slots x10
- System PSU bays x2
- Power over Ethernet (PoE) PSU bays x2
- Fan tray

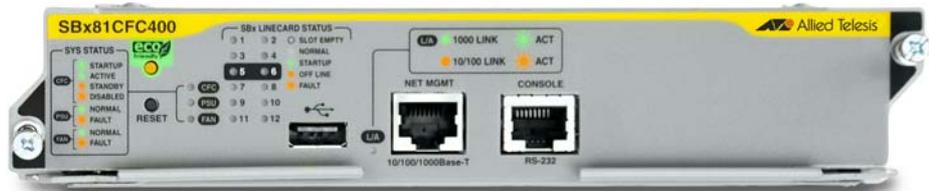
Figure 2: SBx81CFC400

- SBx81CFC400 controller fabric card provides 40Gbps bandwidth per line card slot (80Gbps with 2 control cards)
- 80Gbps x 10 line card slots = 800Gbps per system
- RS-232 and Ethernet management ports for out of band management
- USB connector for external file transfer and storage
- Centralised LEDs provide status of all 12 card slots, CFC, PSU, fan tray

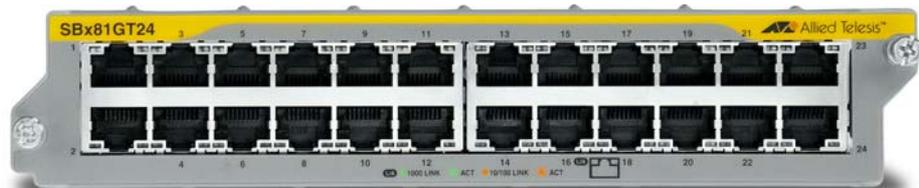
- SBx81GT24 (24 x 10/100/1000T Line Card)

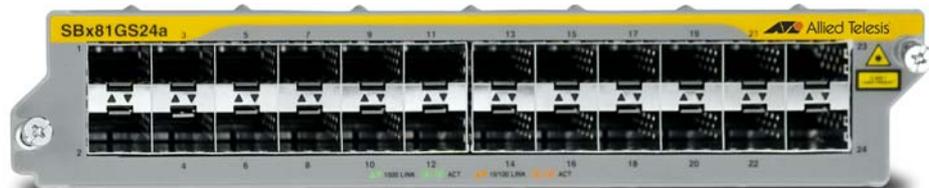
- SBx81GP24 (24 x 10/100/1000T PoE+ Line Card)
- SBx81GS24a (24 x 100/1000 SFP Line Card)

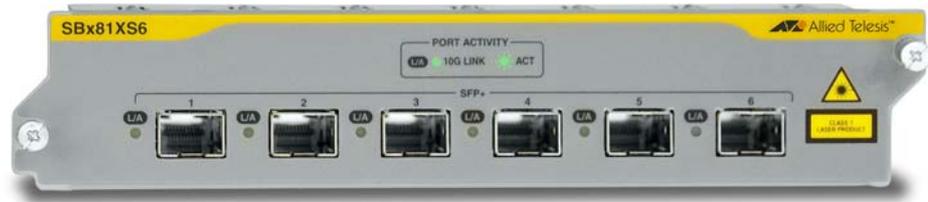
- SBx81XS6 (6 x 10Gbps (SFP+) Line Card)

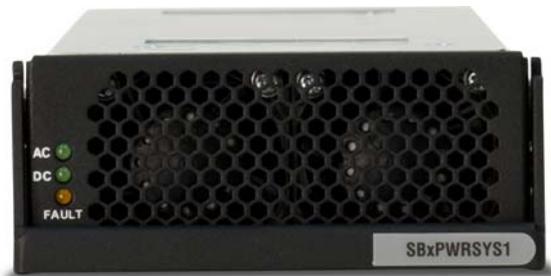
- SBxPWRSYS1 (1200W AC System Power Supply)

The switch operates with one system PSU, and installing a second loadsharing PSU provides ultimate redundancy.

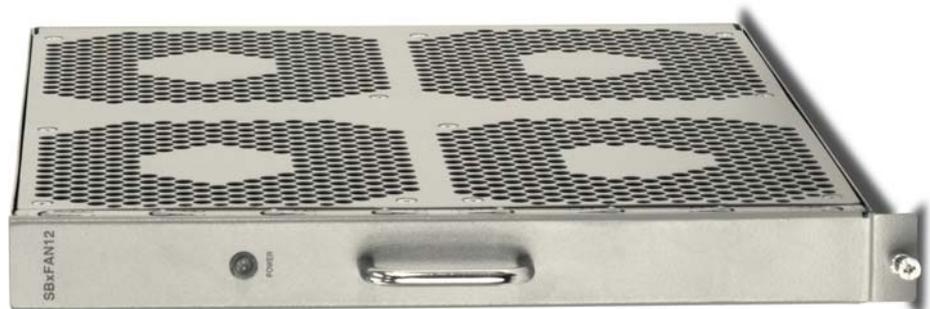
- SBxFAN12 (Fan tray for 12 slot chassis)

The PSUs and the fan tray are all hot-swappable to maximise uptime during maintenance or reconfiguration.
