Tips and Tricks | AlliedWare Plus™ Managed Switches

This document contains useful technical tips and tricks for AlliedWare Plus Managed switches.

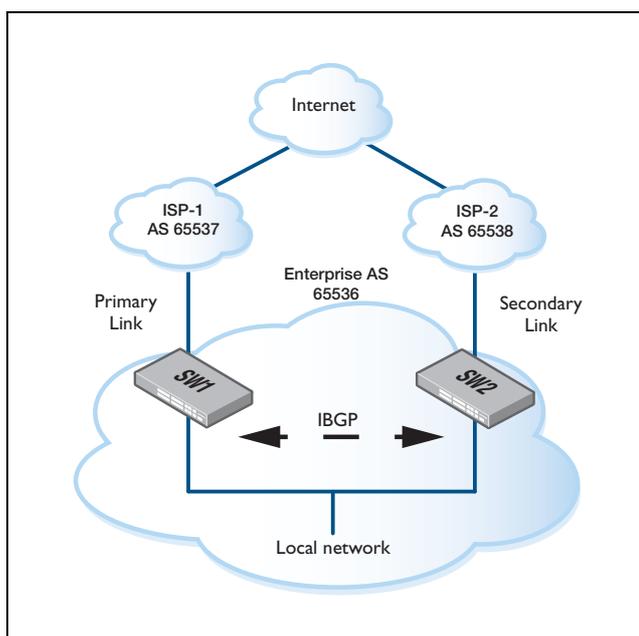
This method involves disabling the automatic preemption of a VRRP router when it joins a VRRP gateway group. By disabling preemption, the device will not automatically re-elect itself as the VRRP Master if it has a higher priority.

This way the current VRRP Master will continue to forward traffic as normal and there will be no network disruption. If the Master fails, then the device will transition from Backup to Master as normal and in most cases the device will have learned all route forwarding information by then.

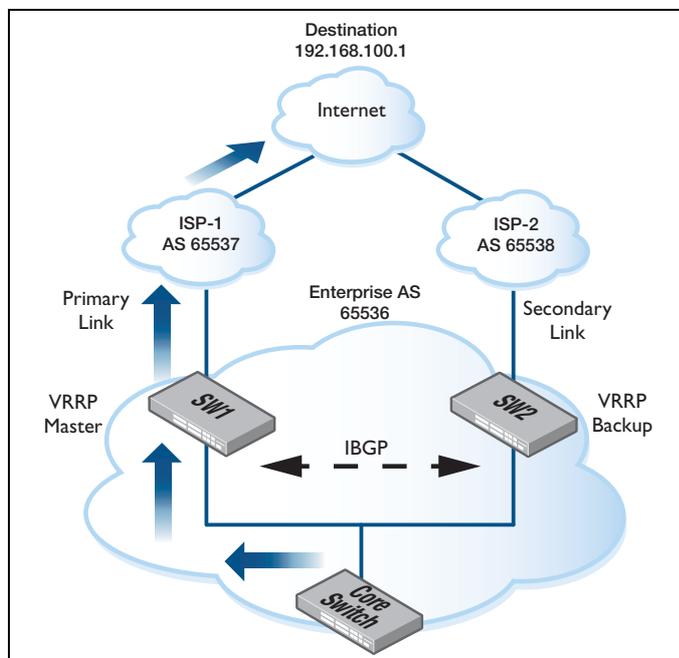
Example of the issue:

- Preemption is on by default.
- SW1 and SW2 use BGP to learn prefixes from the ISPs.
- Advertisement timers are at the default of 1 second (100 centiseconds) so a small amount of packet loss is expected.

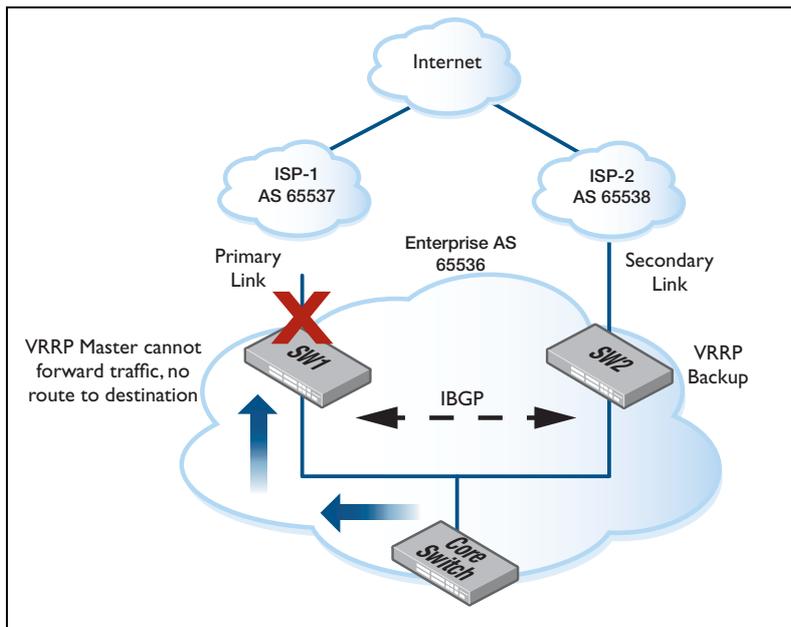
!Due to the VRRP router (SW1) preempting and assuming its place as Master before it has learned the default route from the BGP peers, it is unable to forward packets to the destination.

SW1 finished rebooting and preempted causing it to assume its place as the VRRP Master. This then caused SW2 to re-assume its position as VRRP Backup. Traffic was then forwarded to SW1, but SW1 had not received the default route from either BGP peer yet. If there was no iBGP peering, the time taken to learn the default route from the external peer would be much longer, resulting in additional downtime.

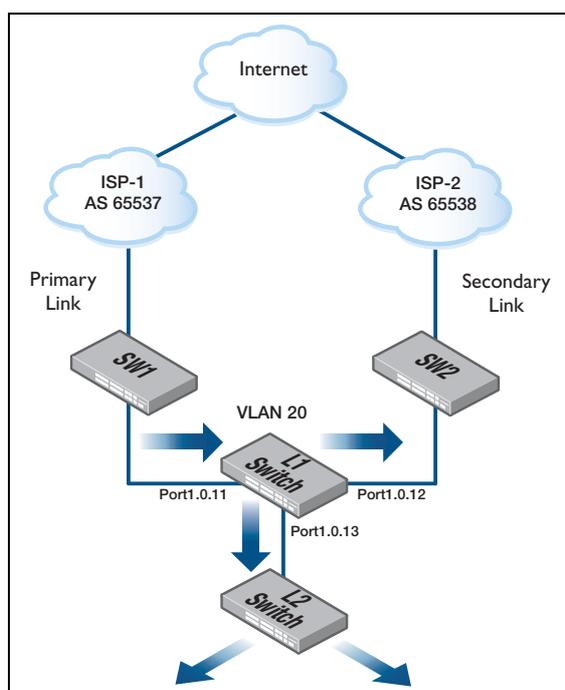
Default VRRP Setup:

- SW1 sends VRRP ADVERTISEMENT messages to 224.0.0.18 and FF02::12 respectively.
- The Layer 2 switch connecting SW1 and SW2 does not perform snooping for the reserved multicast ranges, as per the RFC standard.
- The Layer 2 switch then floods the frame out all ports due to there being no matching entry. Subsequent Layer 2 switches in the topology also flood the frame.
- The result is unnecessary frame transmissions on internal network links.

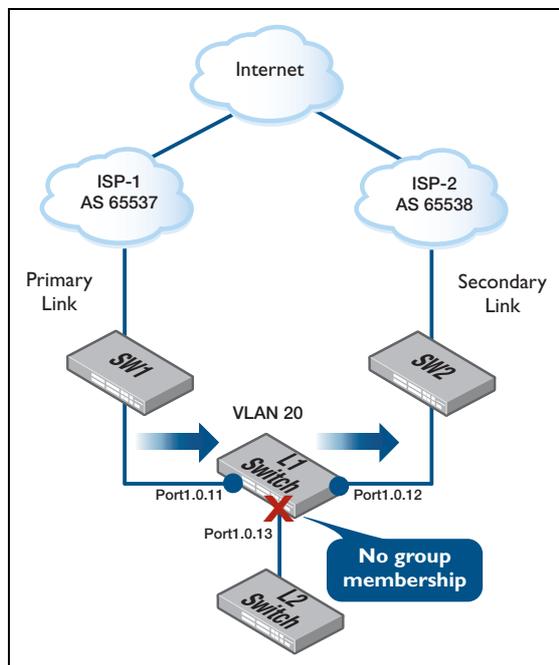
Port 1.0.11 and Port 1.0.12 are now have a static group membership for 224.0.0.18 and FF02::12 multicast groups. VRRP ADVERTISEMENT messages will not be flooded out ports where VRRP routers do not exist. So, port 1.0.13 is not sending VRRP packets.

Care must be taken to configure a static group entry for all ports where a VRRP router is reachable for the VLAN. Failure to include a static membership for a port where a VRRP router resides, will result in no VRRP ADVERTISEMENT messages reaching that neighbor.

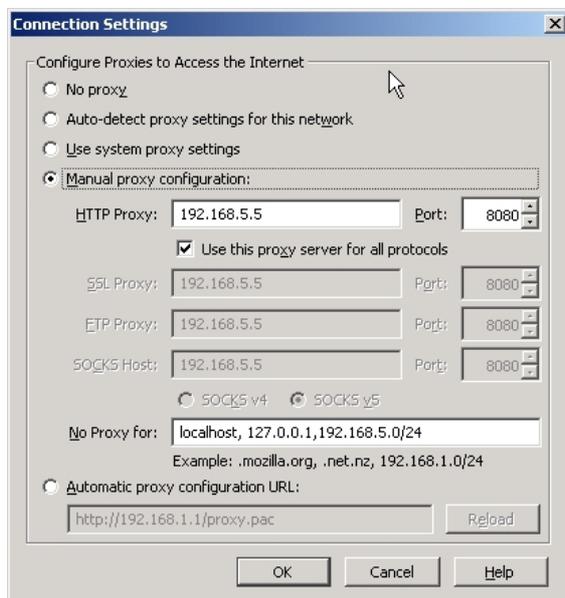
For example, consider the case where the web browser is configured to use 192.168.5.5 TCP port 8080 as its web proxy.

In this case we must also add the network 192.168.5.0/24 into the 'No Proxy for:' list, as shown below:

If the network on which the proxy server is located on is not added to the **No Proxy for:** list, a 'proxy packet loop' will occur. The 'proxy packet loop' occurs because the switch intercepts the HTTP traffic from the supplicant's browser to the web proxy, and sends it a 'fake' response redirecting it to the Web Authentication Login page – in this case the switch at 192.168.5.1.

However, the web browser is configured to use the web proxy at 192.168.5.5 for traffic to network 192.168.5.0/24, and so sends a new request to 192.168.5.5 instead. The switch will intercept this request and the process begins again.

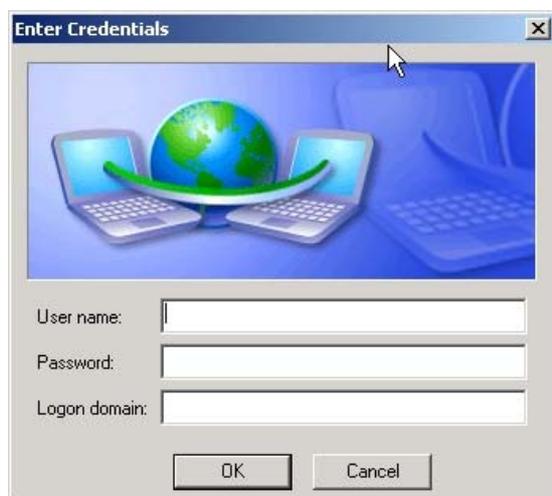
The supplicant's device is automatically MAC authenticated then, if that is successful, the supplicant must then supply their username and password for dot1x authentication.

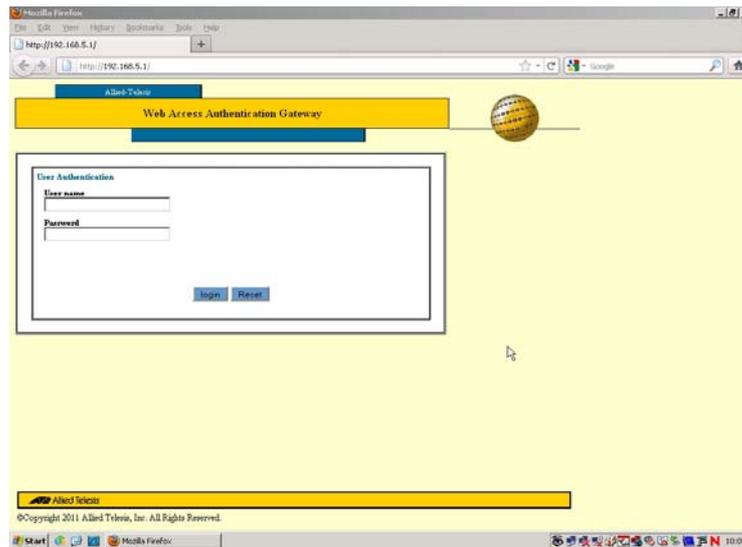
The supplicant's device is automatically MAC authenticated then, if that is successful, the supplicant receives the Web Authentication Login page when their web browser is opened.

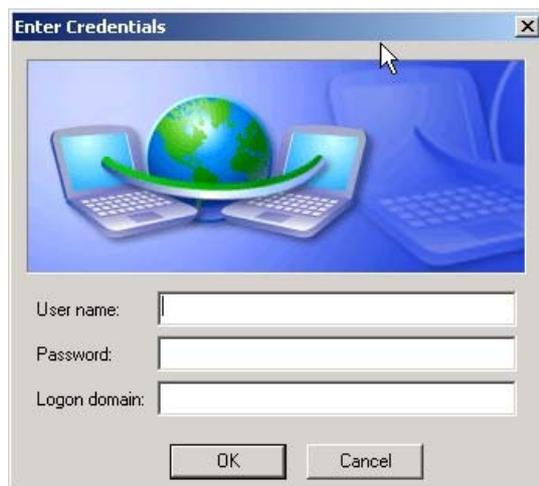
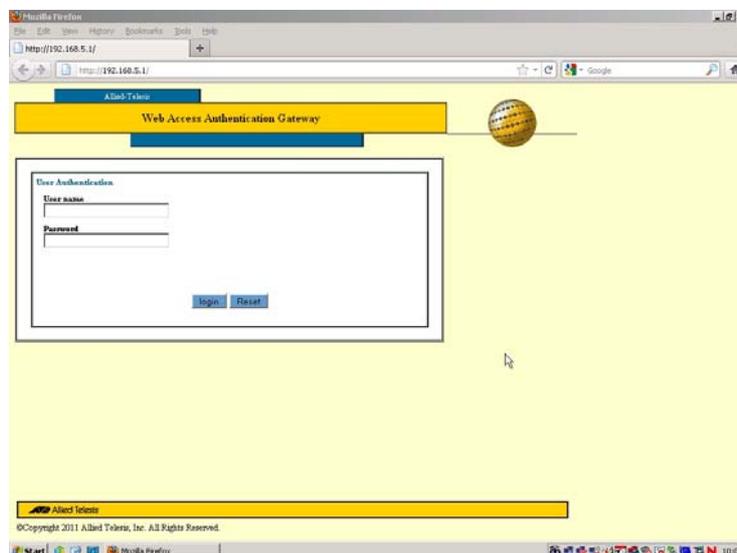
Here the supplicant must first enter their username and password for dot1x authentication then, if that is successful, the supplicant receives the Web Authentication Login page when their web browser is opened.

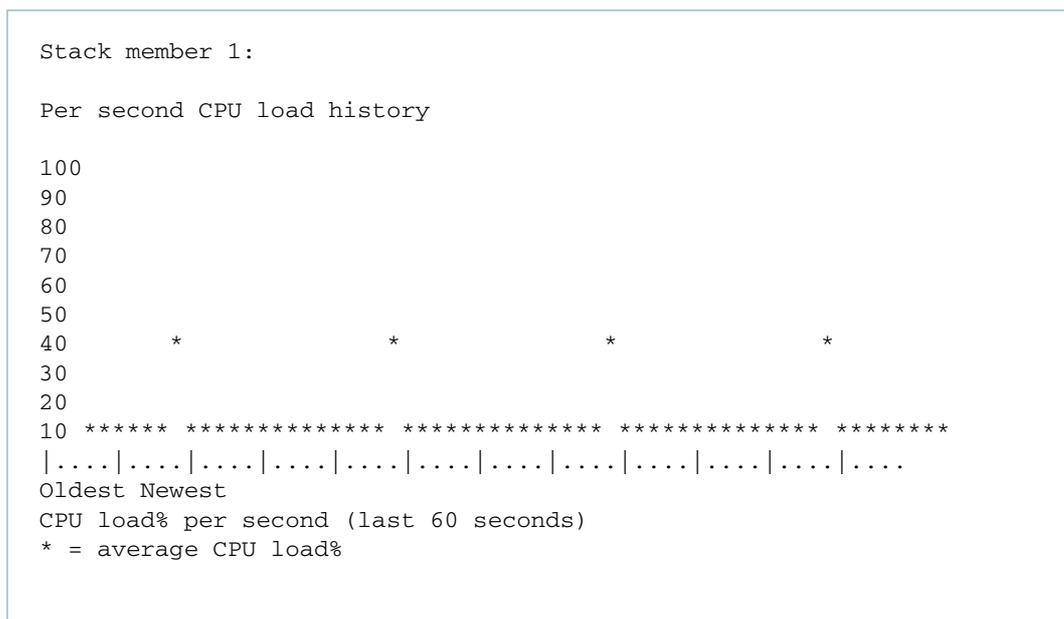
The CPU usage has the potential to spike to 40% every 15 seconds, as shown below:

These spikes in CPU usage are caused by the SNMP protocol. However, this occurs even when the SNMP process is disabled on the switch:

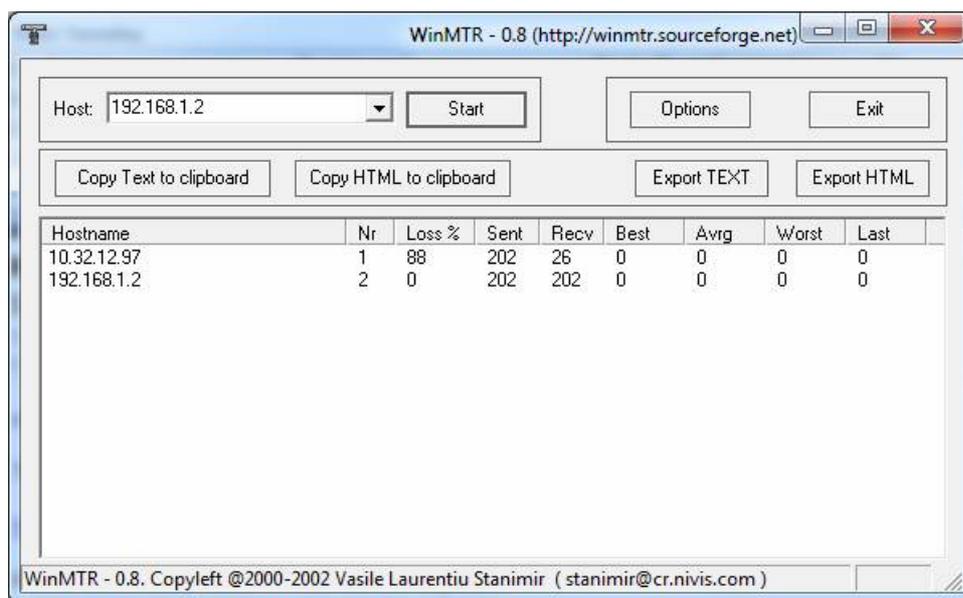
2. When you run this test (ICMP packets at 100ms interval), MTR to 192.168.1.2 shows enormous packet loss:

3. MTR sends two frames every 100ms. These are ICMP echo requests, destined for 192.168.1.2. One has a TTL of 1 and the other has a TTL of 2.
4. The packet with a TTL of 2 reaches its destination and an ICMP echo reply is sent. This is correct.
5. The packet with a TTL of 1 reaches the AlliedWare Plus switch (10.32.12.97) and the TTL expires, so the switch sends back an ICMP Time-to-live Exceeded message. This is also correct.

However, the Linux kernel employs ICMP rate limiting for certain ICMP packets. This means that only around 1 in 10 TTL expired packets will actually result in an ICMP Time-to-live Exceeded message in this scenario. This explains why MTR reports about 88% loss to the SwitchBlade x908.
