## TQ1402 and TQ5403 Wireless Access Point Series Versions 5.4.3 to 6.0.1-2.1 Software Release Notes

### Version 6.0.1-2.1

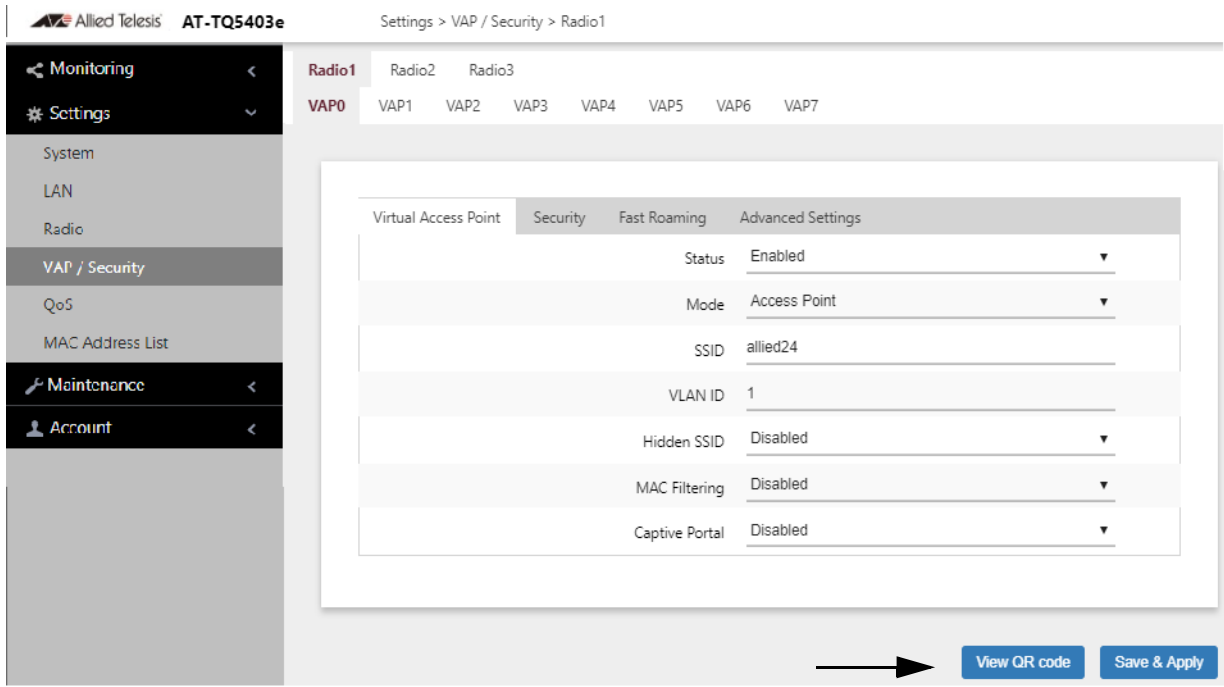
Figure 1. View QR Code Button

- Codes are generated by clicking the View QR Code button in the Virtual Access Point windows in the on-board web browser management interface of the TQ1402 and TQ5403 Wireless Access Point series. Refer to Figure 1 on page 3. The button is also available in the new Easy Setup window in the TQ1402 Wireless Access Point series.
- QR codes are not supported on VAPs that use RADIUS servers or AWC to authenticate wireless clients.
- The wireless access points come with default QR codes for VAP0 for Radio1 and Radio2. The QR codes are the same for both radios. Refer to Figure 2 on page 3.
