## AlliedWare Plus Software Maintenance Release Note

# Software Version 5.4.3-3.17 For SwitchBlade x8100, SwitchBlade x908, x900, x610, IX5, x510 and x210 Series Switches

This document lists the issues addressed and enhancements in AlliedWare Plus software maintenance version 5.4.3-3.17. This document applies to the following switches:

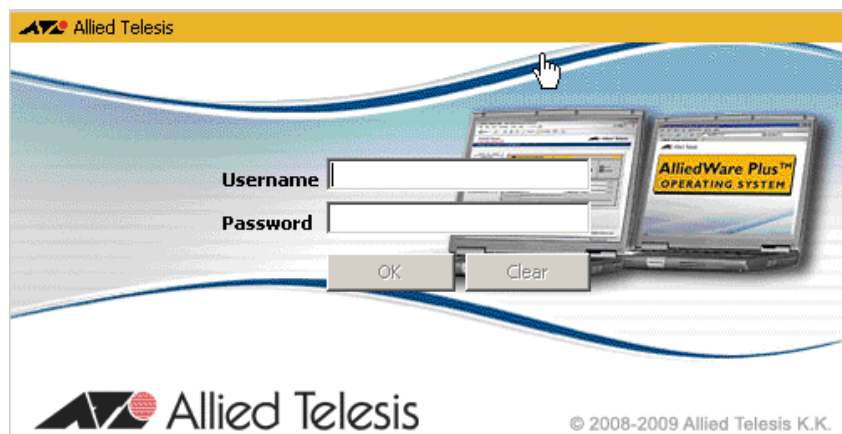
Start a browser and enter the IP address you configured in Step 3 as the URL. You will be presented with a login screen after the GUI Java applet has started. Log in with the username and password that you defined in the earlier step, named [Create a user account](#).

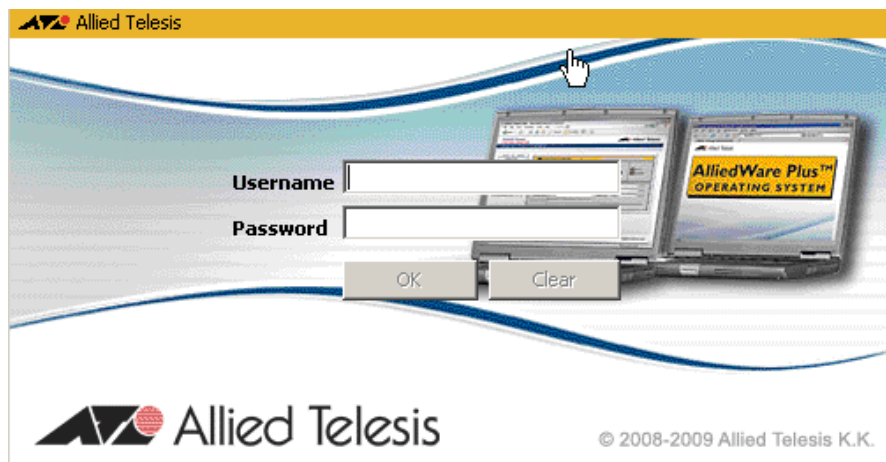
Start a browser then enter the IP address you configured in Step 3 as the URL. You will then be presented with a login screen after the GUI Java applet has started. You can then Log in with the username and password that you defined previously in Step 6.

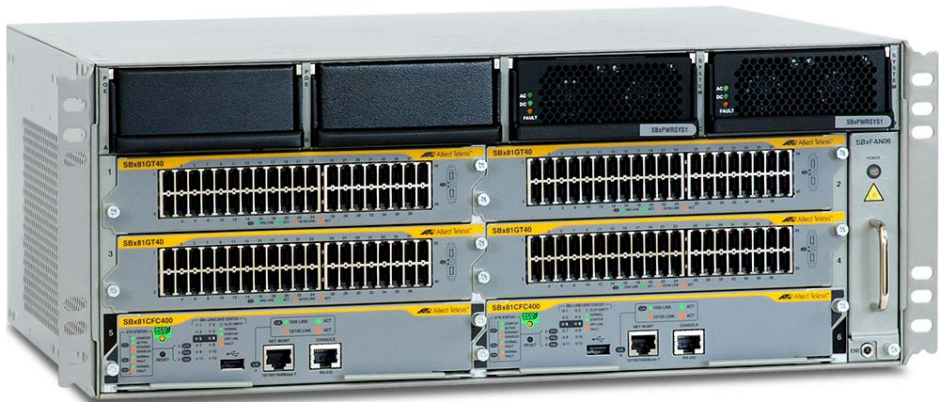
This 6-slot chassis switch shares all the same features of AlliedWare Plus and supports the same line and controller cards as the 12-slot SwitchBlade x8112.

SwitchBlade x8106 with two SBx81GTX40 line cards and two SBx81CFC400 controller cards installed.

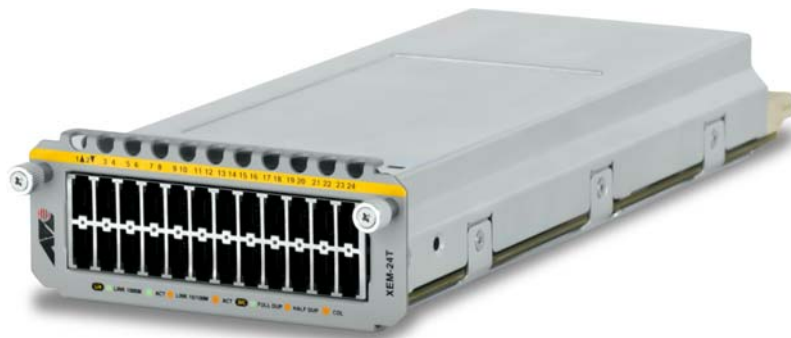
AlliedWare Plus 5.4.3-2.5 supports the new XEM-24T, providing 24 10/100/1000T copper ports, utilizing the latest RJ point five connectors to double the port density previously available. This expansion module can be installed in:

- x900-12XT/S and x900-24X Series switches
- SwitchBlade x908 in standard and extended silicon profile modes

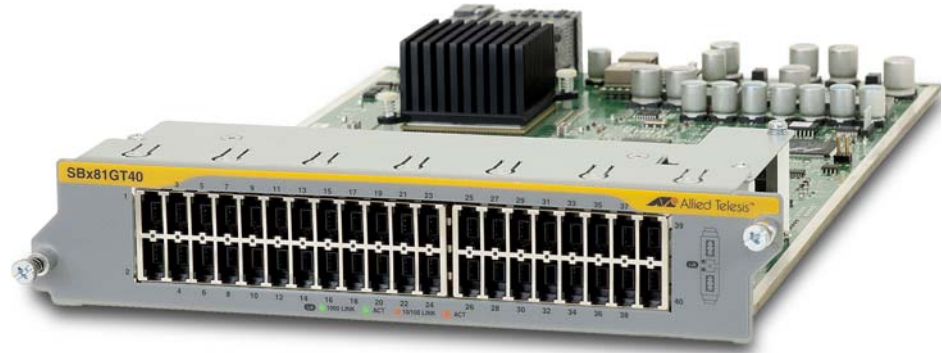
## SBx81GT40

AlliedWare Plus 5.4.3-2.5 supports the new SBx81GT40 40-port Gigabit copper line card, which maximizes port density, utilizing the latest RJ point five connectors. SwitchBlade x8112 can now provide up to 400 Gigabit copper ports in a single 7RU chassis.

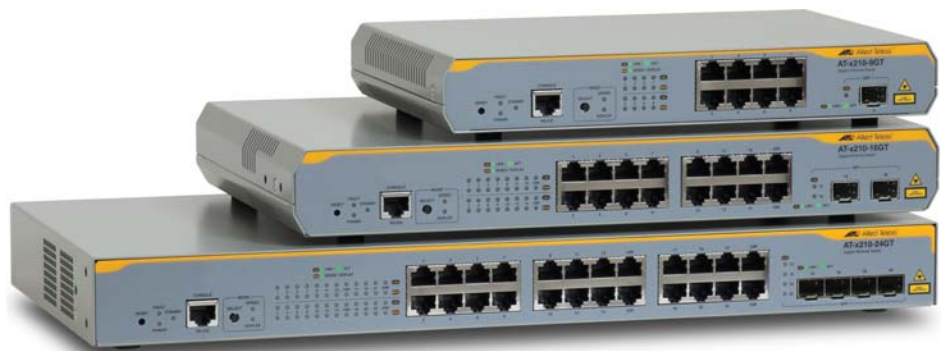
## x210 Series switches

AlliedWare Plus supports the x210 Series switches from version 5.4.3-1.4. The x210 Series is a reliable and value-packed solution for today's networks. With a choice of 9-, 16- and 24-port versions, each with one or more SFP uplinks, the x210 Series switches are ideal for applications at the edge of the network where security and manageability are the key requirements.
